A Disaster Recorded on the Seafloor Palmer-Crary Shipwreck Backgrounder

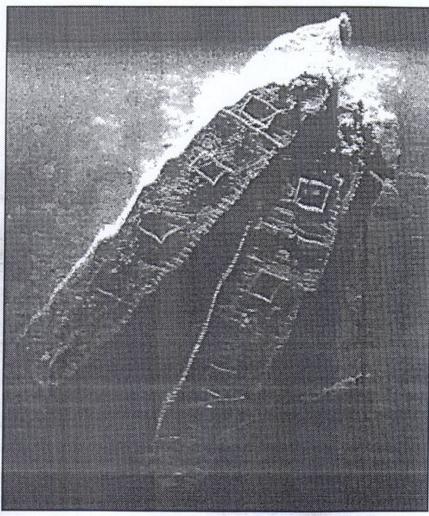
A side scan sonar image shows the wrecks of the Louise B. Crary (left) and Frank A. Palmer (right) sitting on the seafloor of the Stellwagen Bank National Marine Sanctuary(SBNMS image).

The sonar image that came back to the research vessel astounded marine archaeologists on board. Not only are

the two schooners sitting upright on the bottom, but they appear to be locked together just as they sank (according to reports of survivors). It even appears that at least one of the masts may still be in place (lower portion of ship on the right). The hatches to the cargo holds of the two ships are also apparent in the image (*Crary* to left and *Palmer* on right). Future cruises will gather more detailed side scan and video images of these important submerged cultural resources in the Sanctuary.
